Manhole Inspection Summary

Manhole # S25G__015MH

Insp Date: **8/30/07 10:20 AM**

Location Address: **2 CAREY ST**

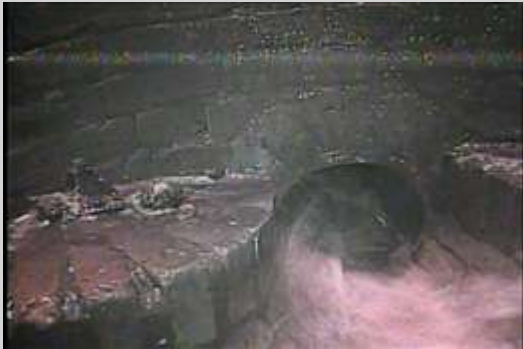
12 O'Clock Outflow

10 in. Circular Gravity Sewer
Pipe Out @ 12 O'Clock

Pipe Height: **10.8** (in.) Rod and Bar (Angled)
Pipe Material: **Clay** ☐ Pipe Lined
Invert Depth: **16.92** (ft.) Flow Characteristics: **Turbulent**
Deposits: ☒ None ☐ Mud ☐ Sludge ☐ Debris ☐ Grease
Silt Depth: (in.) Deposits Extent:
Infiltration: **None** Pipe Seal Cond: **Sound**

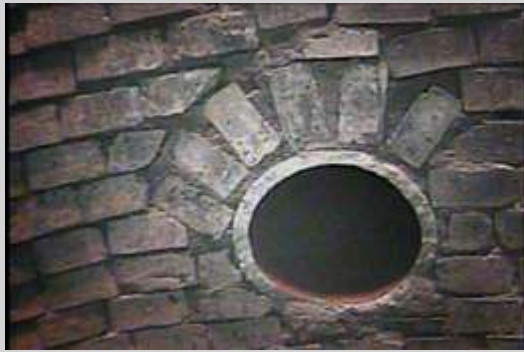
7 O'Clock Inflow

8 in. Circular Gravity Sewer

Pipe In @ 7 O'Clock

Pipe Height: **7.2** (in.) Rod and Bar (Angled)

Pipe Material: **Clay** ☐ Pipe Lined

Infiltration: **None** Pipe Seal Cond: **Sound**

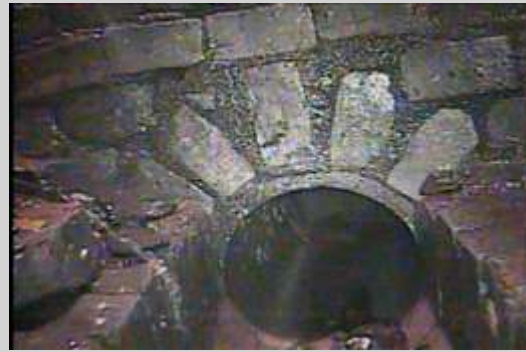
Drop In @ 7 O'Clock

Drop: **Outside** Rod and Bar
Angled: **Yes** Reading: **15.51** (ft.)
Inv Depth: **16.51** (ft.)
Drop Condition: **Open**
